A study of functional and clinical outcome for augmentation plating with tension band wiring for complex patella fractures

Abstract

Keywords: Tension Band Wiring (TBW), Complex Patella Fracture, Augmentation Plating, Patella

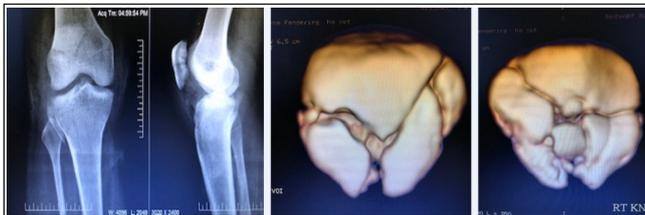
Figure 5: Patient-1 radiograph after surgery
The AP and lateral X-ray images of post-surgery at 1-month (a), 3-months (b), and 6-months (c) follow-up. (d) 8-month follow-up showing fracture union and ruptured ligamentum patellae sutured with SS-wire.

The surgery was performed as described above. Pictures taken illustrate the surgery procedure for patient 1 (Figure 3) and patient 2 (Figure 4). Patients radiographs (Figure 5 and 6) were collected to track if the surgical implants were properly placed or not. The patients were monitored throughout the course of recovery upto 12 months. Full range of motion flexion and extension achieved in all patients at the end of 12 months (Figure 7).

The procedure is safe and there were no associated complications with the technique except for the one patient who was treated with 2.7 mm low profile plate along with tension band wiring who sustained a subsequent fall at the 8th month of the primary surgery and had a ligamentum patellae rupture from the apex of patella which was treated with another surgery in form of fixation of the same using S S wire. The patient had earlier restriction of motion after the second surgery but with due physiotherapy the functional outcome was eventually excellent.
